Development of GFRP-Reinforced Concrete Bridge Barrier-Deck Slab Details to Resist Equivalent Vehicle Impact Loading

H.R Khederzadeh¹ and K. Sennah¹

¹Civil Engineering Department, Ryerson University, Toronto, Ontario, Canada M5B 2K3

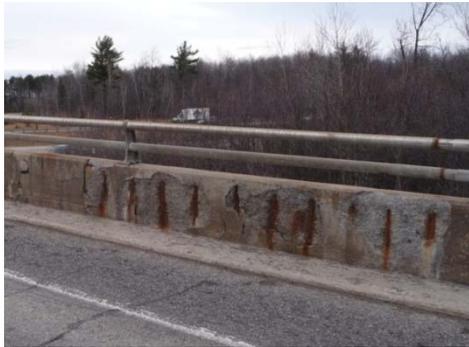
Fig.1 Corrosion-induced degradation of steel-reinforced bridge barrier wall

Conventional Bridges built prior to the 1970's did not use air-entrained concrete and coated reinforcing steel bars to protect from the effects of freeze-thaw cycles and the application of winter de-icing salt. This leads to corrosion-induced degradation in bridge elements as shown in Fig. 1. Accordingly, exposed bridge elements are all likely candidates for expensive replacement on the majority of these older bridges. In November 2007, The Residential and Civil Construction Alliance of Ontario, Canada, (RCCAO 2007) released a report on the state of Ontario bridges, entitled "Ontario's Bridges: Bridging the Gap." The report warns that the integrity of Ontario's municipal bridge infrastructure and public safety are at risk after years of deferred maintenance, irregular inspections, and lack of government oversight. The RCCAO report stated some recommendations to be made to promote the public's safety and the sustainability of Ontario's bridges. One of these recommendations includes promoting bridge engineering designs that improve the life expectancy and reduce maintenance costs of bridges. This can be achieved by using fibre reinforced polymer bars.

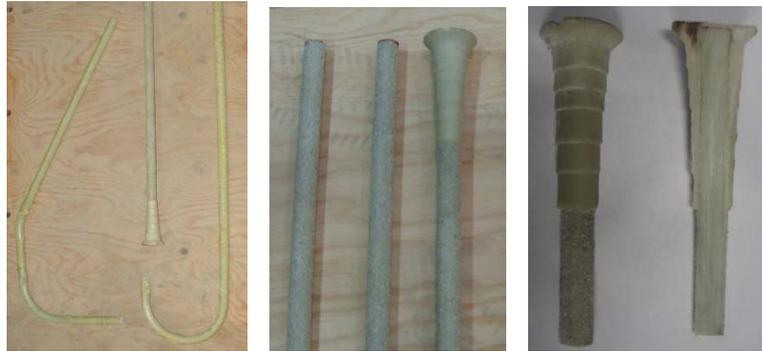
Fig. 2 View of GFRP bars types

Fibre-reinforced polymers (FRPs), as non-corrodible materials, are considered as excellent alternative to reinforcing steel bars in bridge decks to overcome steel corrosion-related problems. Since it is less expensive than carbon and aramid FRPs, Glass FRP (GFRP) bars are more attractive to bridge deck and barrier applications. Two types of GFRP bars were considered in used in this study, namely: (i) GFRP bars with high modulus (HM) and (ii) GFRP bars with standard modulus (SM). The sand-coated surface profile of these bars, shown in Fig. 2, ensure optimal bond between concrete and the bar. Table 1 summarizes the material

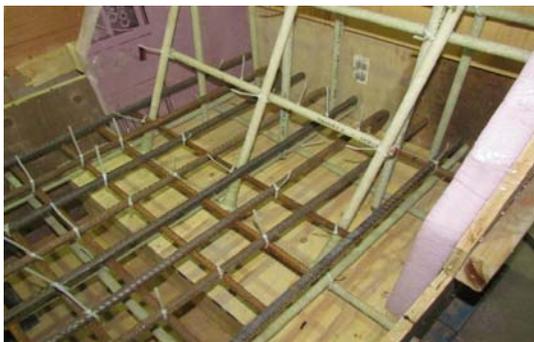
Fig. 5 View of GFRP bars in Model 1

Model 1 was constructed using High-Modulus (HM) GFRP bars as shown in Fig. 4(a). 15M HM-GFRP bars with head end were placed at 300 mm c/c spacing in front face of the barrier at deck-barrier joint. In addition, 15M HM-GFRP bars were placed in the front face of the barrier wall extending into the deck slab at 300 mm spacing. 12M HM-GFRP bars were placed as horizontal reinforcement as well as vertical reinforcement in back face of the wall at 300 mm spacing. Figure 5 shows view of GFRP bar arrangement in Model 1. Model 2 incorporated Standard Modulus (SM) GFRP bars in the barrier wall as depicted in Fig. 4(2). At the junction of barrier to the deck slab, M15 GFRP bent bars were placed at 200 mm spacing in the barrier front face. In addition, M15 GFRP bars were placed at 200 mm spacing in the top tapered portion of the front face of the barrier, with the bars extended into the deck slab as shown in Fig. 4(2). M12 GFRP bars at 200 mm spacing were used as horizontal bars as well as vertical bars in back face of the barrier wall. Figure 6 shows view of GFRP bars in Model 2 before concrete casting.

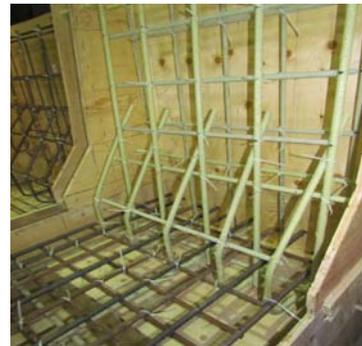
Fig. 6 View of GFRP bars in Model 2

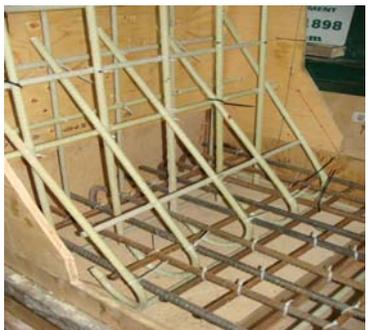
Fig. 7 View of barrier model 3

Similar to barrier model 2, barrier model 3 was built using SM GFRP bars but with 180° hook at the junction of deck slab to the barrier wall. The SM GFRP bars placed on other locations in this model were identical to model 3. Figure 7 shows view of the placement of GFRP of bars in the formwork. Model 4 was constructed similar to model 1 except that the HM GFRP vertical bars were placed at 150 mm center-to-center spacing representing the barrier wall at its ends or at the construction joint locations. However, the spacing for GFRP horizontal bars as well as vertical bars in the back face of the wall was kept as 300 mm. Figure 8

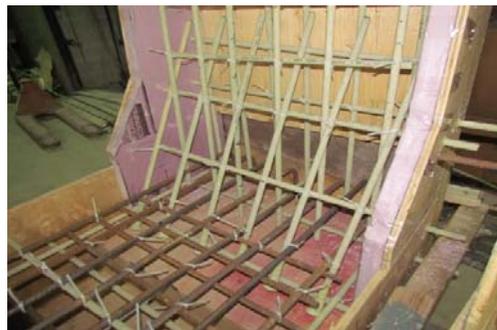
Fig. 8 View of barrier model 4

shows a view of formwork with GFRP installation prior to concrete casting. Model 5 was constructed as reference sample using conventional steel reinforcement, as per MTO standard drawings for reinforced steel bridge barriers. Figure 9 shows a photo of this barrier model with steel reinforcement in front and back face of the wall as vertical and horizontal reinforcements. The M15 steel bar with 180° hook was placed to reinforce the top tapered portion of the barrier front face, while M15 bent bars were placed on the bottom tapered portion, all at 200 mm center-to-center spacing. M12 steel bars were placed in the model as horizontal bars as well as vertical bars in back face of the wall at 300 mm spacing. Table 2 summarises barrier configurations considered for testing in this study.

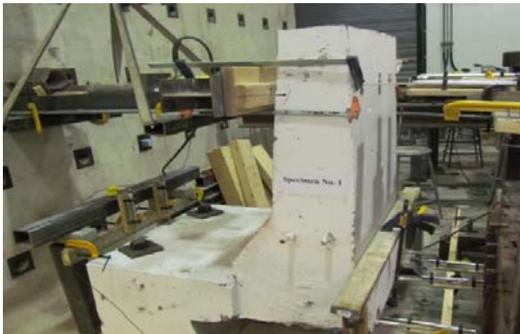
Fig. 11 View of the barriers test setup

Figure 11 depicts view of the test setup for the tested barrier walls. As mentioned earlier, the barriers had concrete strength of 25.4 MPa. Barrier model 1 with HM- GFRP bars of headed end spaced at 300 mm c/c was tested to-complete-collapse. It should be noted that the length of this barrier was 900 mm in longitudinal direction. The load was applied at 990 mm above the deck slab per CHBDC for PL-3 barriers tested under static test. The load was applied manually using hydraulic jack and load increments were captured by load cell attached to the system. The load was applied in increments of 10 kN to observe the crack initiation in the barrier wall and the slab. The first visible flexural crack appeared at the junction of barrier wall-to-deck slab at load of 20 kN as depicted in Figs. 12 and 13. With load increase, cracks were further developed at the corner of deck-to-slab junction down into the deck slab. Similarly, cracks were initiated in the deck slab at 25 to 30 kN due to combined flexure and tension. At a load of 40 kN, flexural crack was observed at the junction of the upper and lower portions of the tapered wall. At this loading stage, cracks started to propagate horizontally through the thickness at the intersection of deck-to-barrier in addition to the cracks observed earlier in the slab. The cracks propagated significantly till the barrier reached the failure load of 95.49 kN. The barrier primary failure took place at the corner of deck-to-slab interface due to flexural mode of failure. As such, the ultimate moment resisted per meter length of the barrier wall was $95.49 \text{ kN} \times 0.99 \text{ m height} / 0.9 \text{ m width} = 105.04 \text{ kN.m/m}$ which is greater than the CHBDC factored design moment of 83 kN.m/m shown in Table 2 for interior locations of the barrier wall. At failure stage, the average ultimate lateral deflection of barrier wall was recorded as 41.61 mm, while the deck slab showed an average horizontal movement of 1.63 mm. At failure, an average deck uplift of 2.87 mm was observed. Figure 14 shows load-deformation curves recorded for model 1.

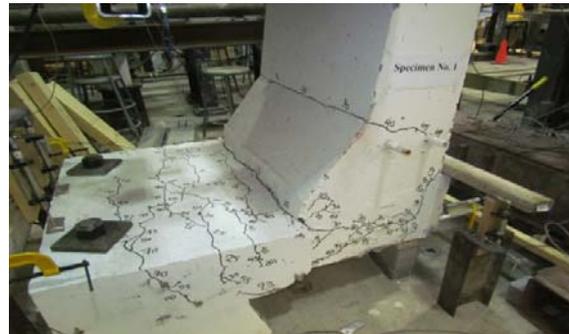
Fig. 12 View of the crack pattern in barrier model 1 with HM-GFRP bars at 300-mm spacing (right side)

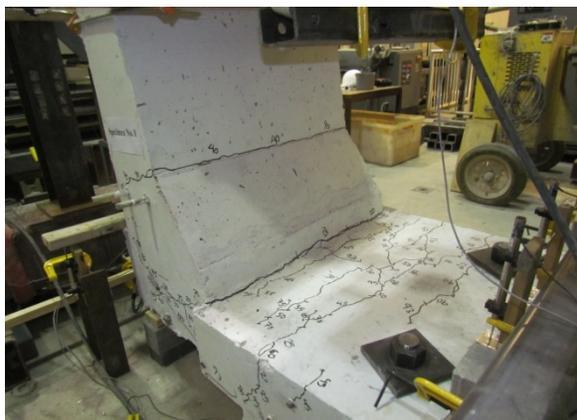
Fig. 13 View of the crack pattern in barrier model 1 with HM-GFRP bars at 300-mm spacing (left side)

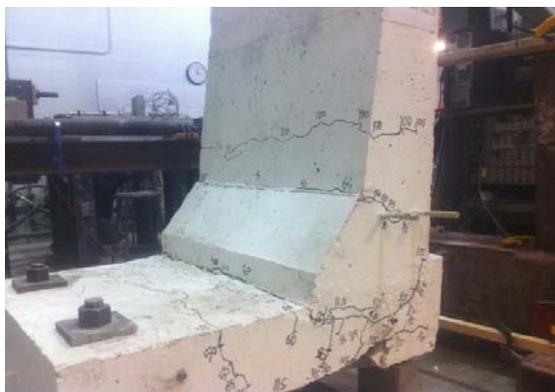
Fig. 15 View of the crack pattern in barrier model 2 with SM-GFRP bent bars at 200 mm spacing

In barrier model 2, Standard Modulus GFRP bent bars were placed vertically in the front face of the barrier wall at 200 mm spacing. The barrier had a length of 1000 mm in the longitudinal direction. The load was applied at 990 mm above the deck slab similar to barrier model 1. Figure 15 shows view of the crack pattern at failure. In this barrier model, the first flexural crack was observed at the fixed end of the deck slab at load of 40 kN. By increasing the load to 50 kN, cracks were further developed in the deck slab and vertical cracks appeared on each side of the deck slab due to combined tension and flexure loading. At 60 kN load, horizontal flexural crack was observed at the deck-to-barrier junction. A similar flexural crack was initiated at junction of the upper and lower portion of the tapered wall at load increment of 65 kN which was further developed into the wall thickness at higher load. At the load range of 70 to 100 kN, cracks propagated further into the slab and barrier thicknesses. At 100 kN load, a flexural crack was observed in the top tapered portion of the barrier wall. With increase in applied load, cracks propagated further into the deck thickness at the barrier-deck junction that led to failure at 116.32 kN primarily due to flexural crack barrier-deck region. As such, the maximum moment reached at failure of deck-to-barrier junction was $116.32 \text{ kN} \times 0.99 \text{ m} = 115.2 \text{ kN.m/m}$. This ultimate load carrying capacity was greater than the factored design moment of 83 kN.m/m specified in CHBDC at interior location as shown in Table 2. The barrier wall exhibited an average lateral deformation of 46.43 mm with deck horizontal movement of 4.37 mm and deck uplift of 5.3 mm at failure. The load-deformation curves captured by LVDT's are displayed in Fig. 16.

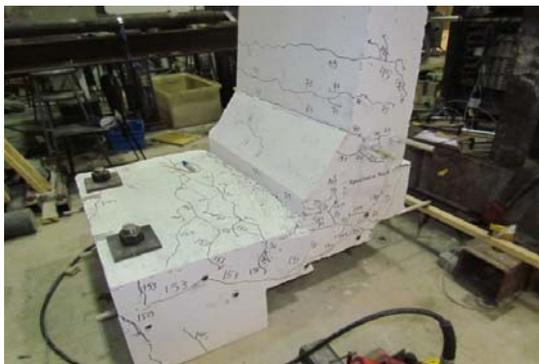
Fig. 19 View of the crack pattern in barrier model 4 with HM-GFRP bars at 150 mm spacing

In barrier model 4, the vertical High-Modulus GFRP bars were placed at 150 mm spacing in the front face of the barrier wall. Similar to other barriers, the load was applied 990 mm above the deck. Figure 19 shows view of the crack pattern of model 4 at failure. The first visible flexural crack was observed at the barrier-

deck joint at a load of 25 kN. Further cracks due to combined flexural and tension appeared in the deck slab with further increase in applied load. At 60 kN, flexural crack was observed at the junction of the top and bottom tapered portion of the barrier wall. At 70 kN load, a similar flexural crack was observed right above the junction between the top and bottom tapered portion of the wall and propagated significantly through the thickness at the same load increment. At this load increment, cracks were also propagated through thickness at the corner of the barrier-to-deck junction. At 95 kN load, a second flexural crack was observed in the top tapered portion of the wall barrier-deck corner, leading to barrier failure at 153.3 kN. The failure of the barrier occurred at lower portion of the deck slab due to concrete splitting at the compression side of the slab under the barrier wall. The experimental results led to a maximum applied moment at the barrier-deck junction of $153.32 \text{ kN} \times 0.99 \text{ m} / 0.9 \text{ m} = 168.6 \text{ kN.m/m}$ which is far greater than the CHBDC factored design moment of 102 kN.m/m at barrier end location as shown in Table 3. It should be noted that the average lateral deformation of the barrier wall was 50.13 mm, with 5.53-mm average deck horizontal movement and 2.47-mm average deck uplift at failure as depicted in Fig. 20 for model 4.

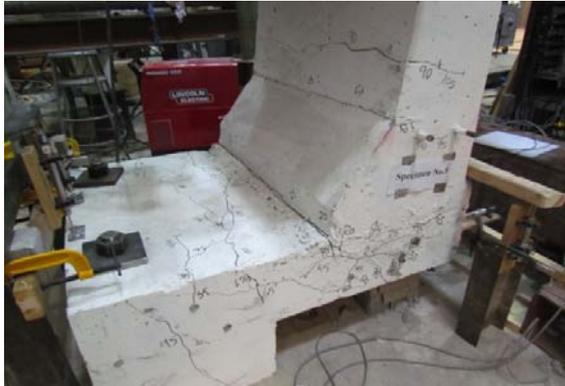
Fig. 21 View of the crack pattern in barrier model 5 with steel bars at 200 mm spacing

Barrier model 5 was constructed as reference model to compare the results with barrier models reinforced with GFRP bars. In this model, M15 steel bars were placed vertically in front face of the barrier wall at 200 mm spacing. Similar to GFRP-reinforced models, the load was applied at 990 mm above the deck slab. Figure 21 shows view of the crack pattern observed in barrier model 5 at failure. At load step of 20kN, the first visible flexural crack was observed at the barrier-to-deck junction, which was extended down into the slab at the corner of deck-barrier joint. With load increase to 50 kN, few flexural cracks were observed in the deck slab extending through the deck thickness. In addition, at load step of 50 kN, a flexural crack was developed at junction of the top and bottom tapered portion of the wall, which was extended into the wall thickness with load increase. With increase in load to 85 kN, few cracks were developed horizontally at the corner of the deck-barrier wall. With increase in the load to 105 kN, other flexural crack was observed in top portion of the tapered wall and propagated through the wall thickness with load increase. In addition, more

flexural cracks appeared at the top surface of the deck slab. With further increase in load, cracks widened, leading to barrier failure at 128.92 kN at corner junction of deck-to-barrier wall under combined tension and flexure. Results led to a maximum moment at the barrier-deck junction of $128.92 \text{ kN} \times 0.99 \text{ m} = 127.63 \text{ kN.m/m}$ which is far greater than the CHBDC factored design moment of 83 kN.m/m at interior location. The barrier wall displayed an average 32.81- mm maximum lateral deflection, with 5.03-mm deck slab horizontal movement and 2.67-mm deck uplift at failure as depicted in Fig. 22 for model 5.
